CENTAUR AC-4 NOSE FAIRING JETTISON TESTS

by Jack C. Humphrey
Lewis Research Center
Cleveland, Ohio

Abstract

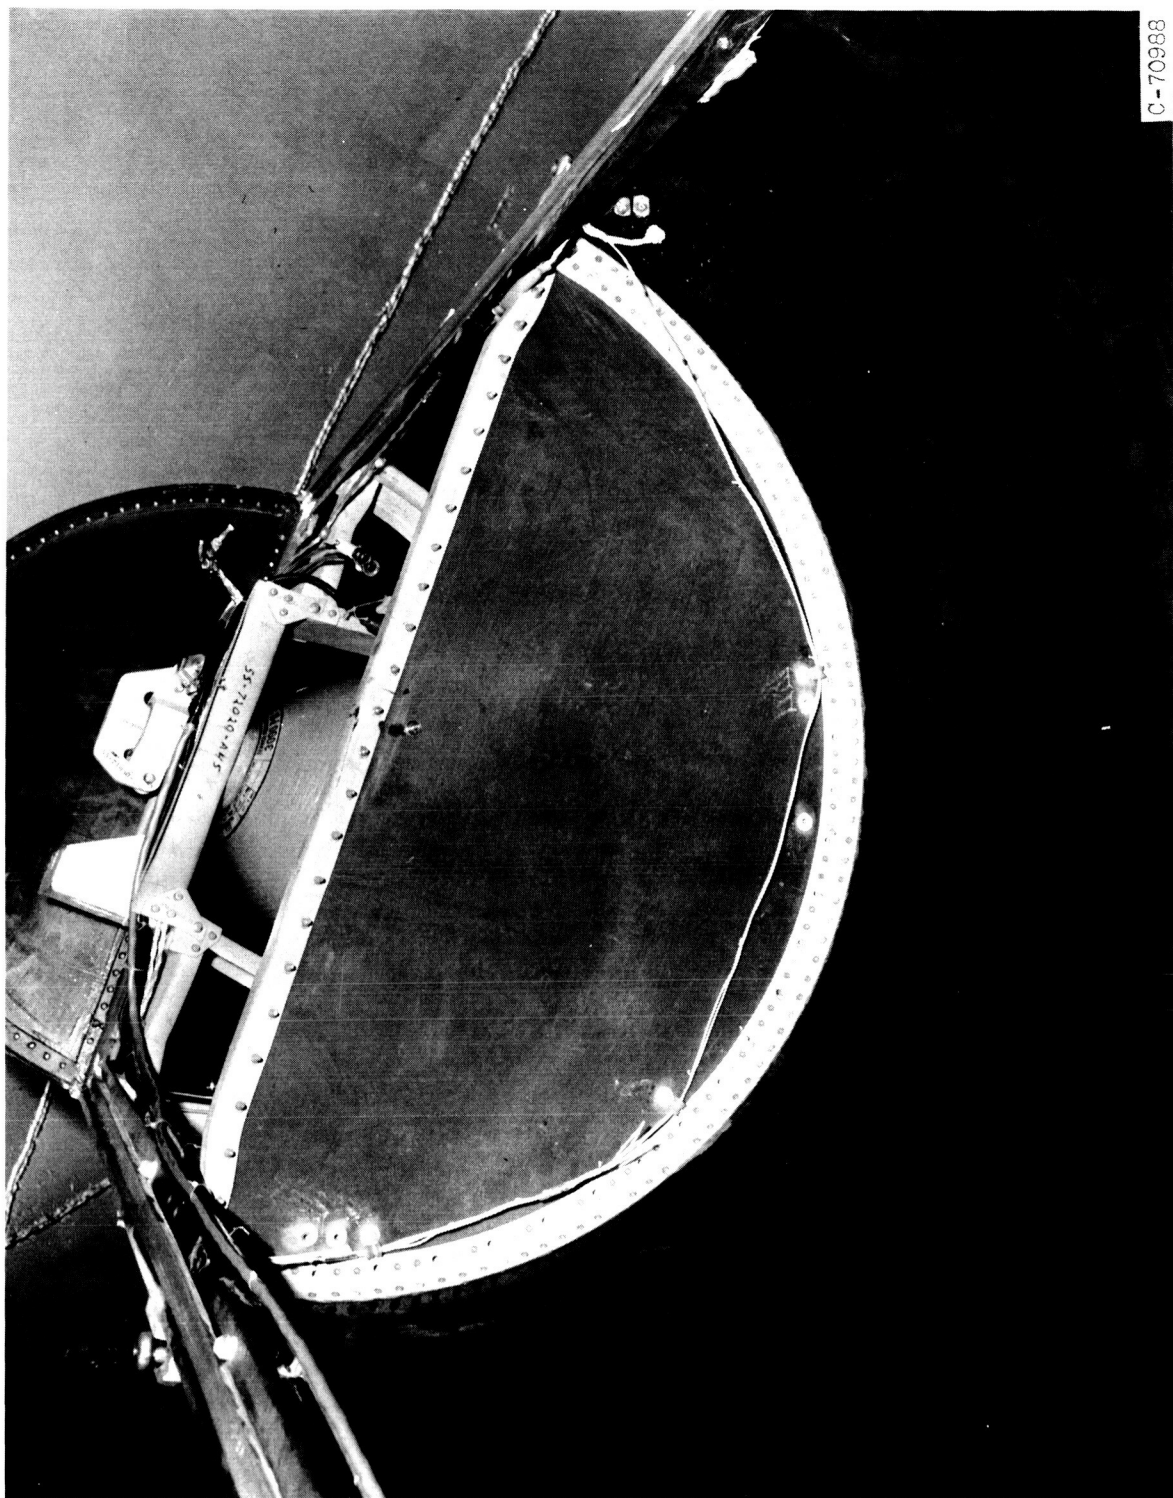
(d) Deflector bulkhead-AC3 type.

The purpose of the deflector bulkhead is to minimize pressure impingement on the payload during nose fairing jettison. The bulkhead was originally designed (fig. 1(d)) as two butting semicircular halves with the capability of withstanding a differential pressure varying from 4.5 psi at the free edge to 9.0 psi at the intersection of the bulkhead, fairing, and Y axis (ref. 1). Tests 1 and 2 were conducted with this type of bulkhead and with jettison bottle pressure and configuration the same as used in the AC-3 flight. Test 1 was conducted at sea level test chamber pressure and no damage to the bulkhead was observed. Test 2 was conducted with a chamber pressure equivalent to that at an altitude of 70 miles. In this test both halves of the bulkhead were torn from the fairing. High speed motion pictures of the II-III half of the bulkhead show this action occurring at approximately 0.015 seconds after the first motion of the fairing. Figure 10(b) is one frame of the test 2 motion picture showing the bulkhead being torn from the fairing. Jettison bottle pressures used this test were 2800 psi (fig. 12), and measured pressures on the deflector bulkhead (fig. 11) varied from 20 to 10 psia. Pressures in the payload cavity are also shown in figure 11 and varied from 6 psia at station -8.0 to 1 psia at station 24.5.

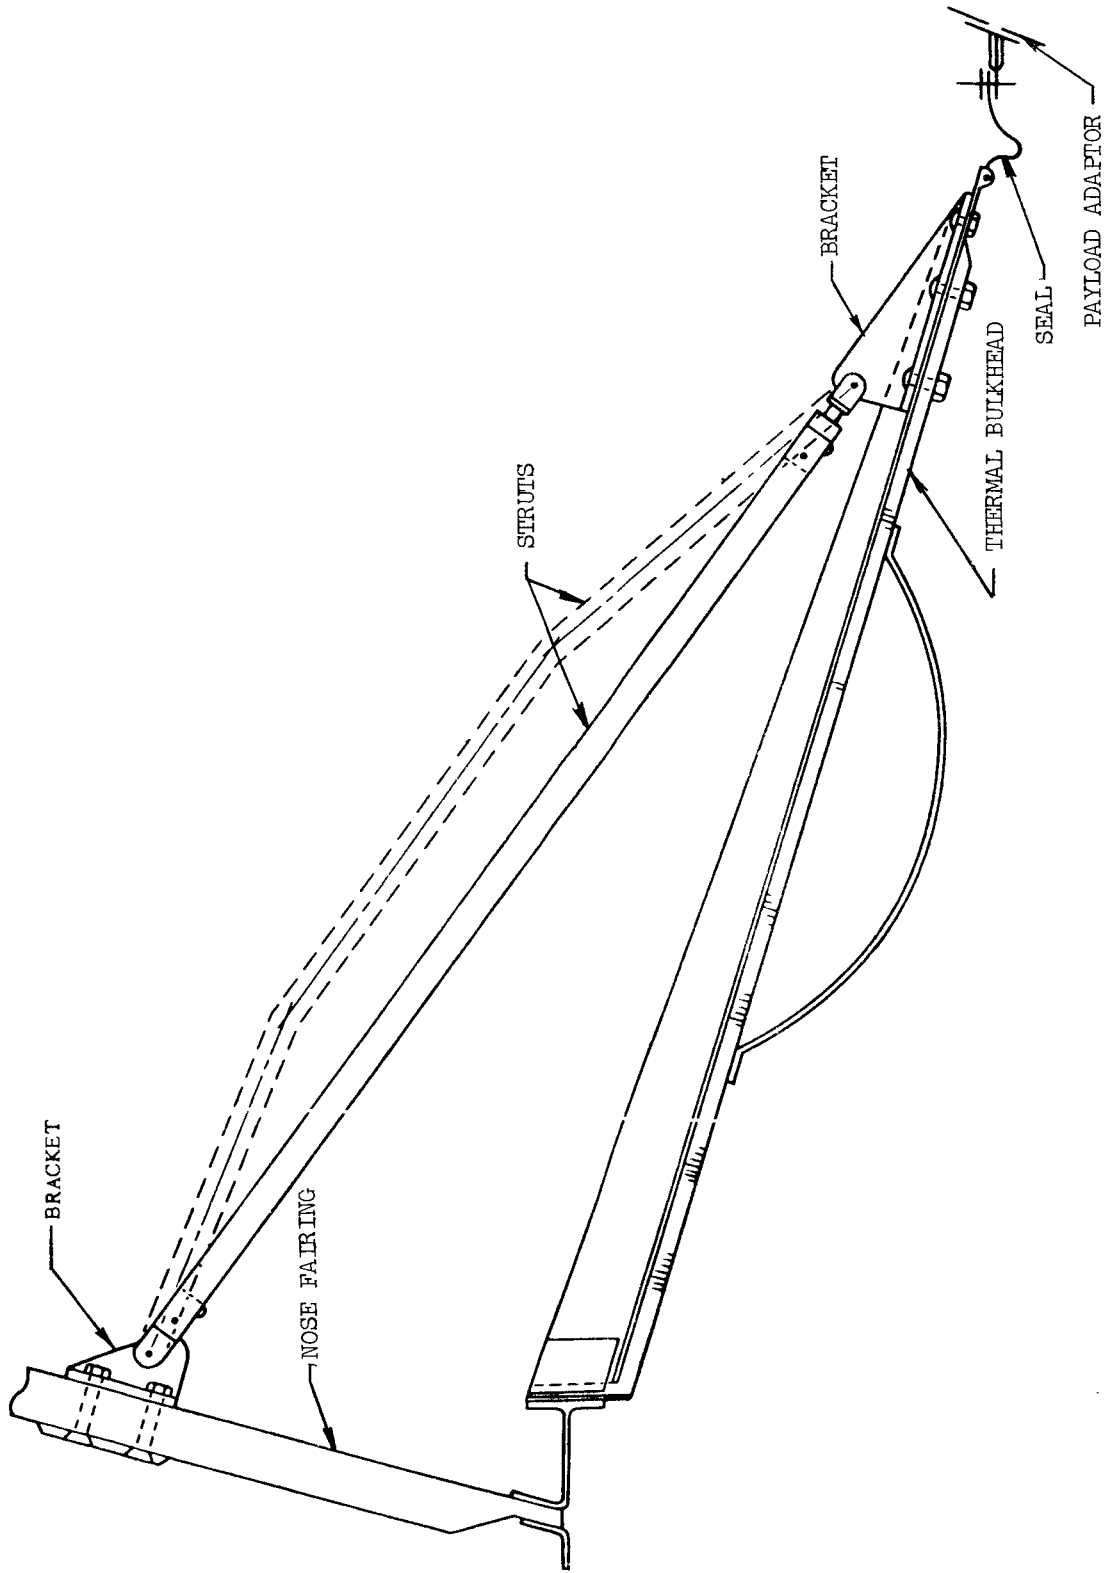
(g) Thermal bulkhead and struts.

Thermal Bulkhead Struts Damaged During Nose Fairing Separation Tests

Test Number	Damaged Struts Position as per Sketch	Type of Failure
7	8	Compression bending of strut at connection to fairing
8	3, 5	Damage to both same as test 7
9	2, 3, 4 and 8	Struts 3, 4, and 8 broken at fairing bracket connection Strut 2 bent in center
10	2, 3	Struts bent at center
11	3	Strut broke at fairing bracket connection
12	3	Strut bent at fairing bracket connection
13	3	Strut bent in center

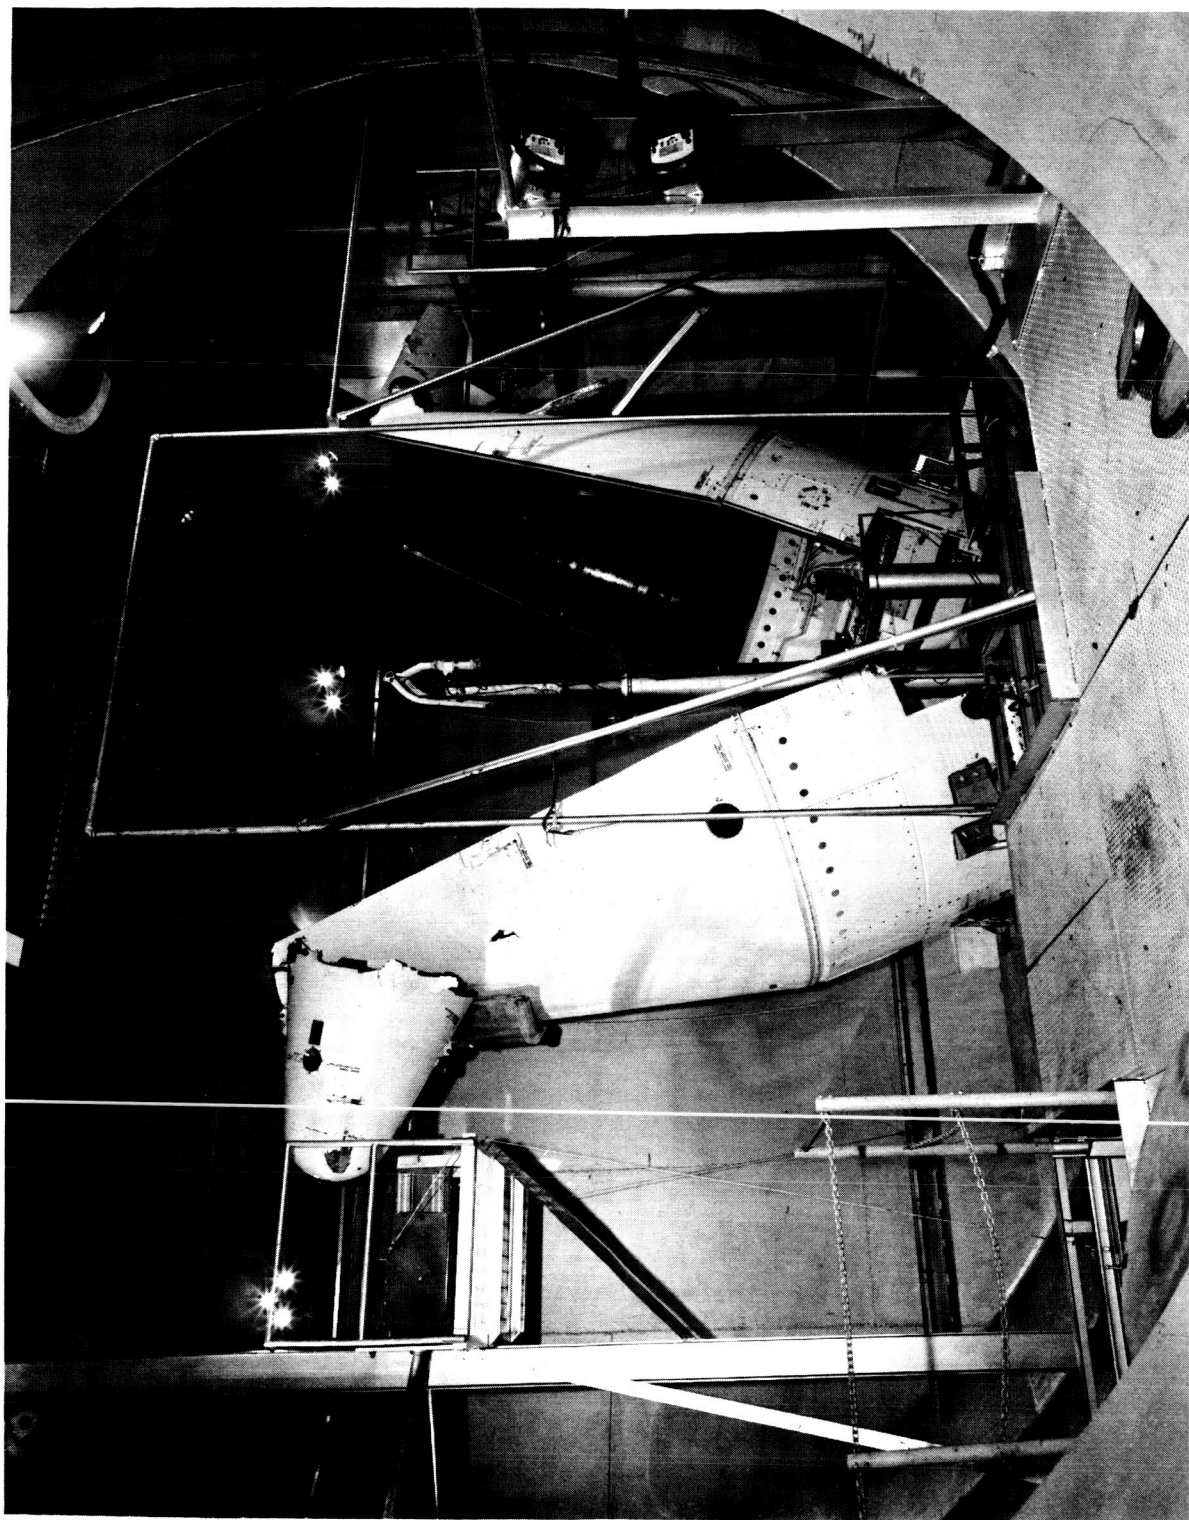
(a) Overall view.

Figure 10. - Damage caused by test 2.

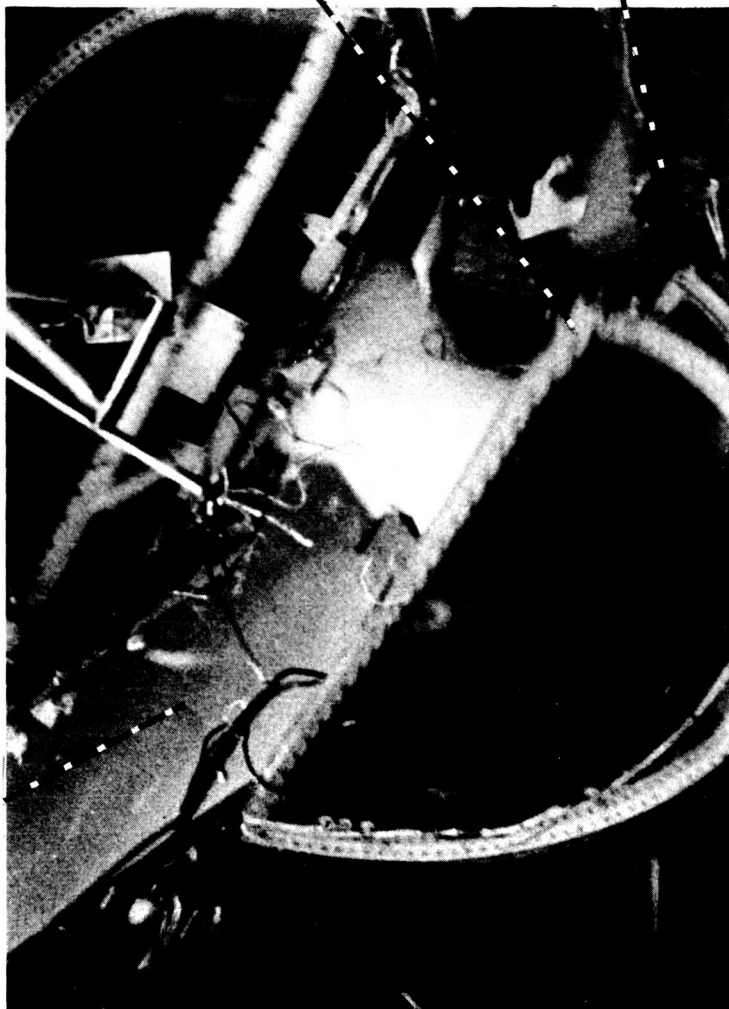
Original point of attachment

Deflector bulkhead,
quad II-III

(b) Deflector bulkhead being torn from
nose cone.

Figure 10. - Concluded.

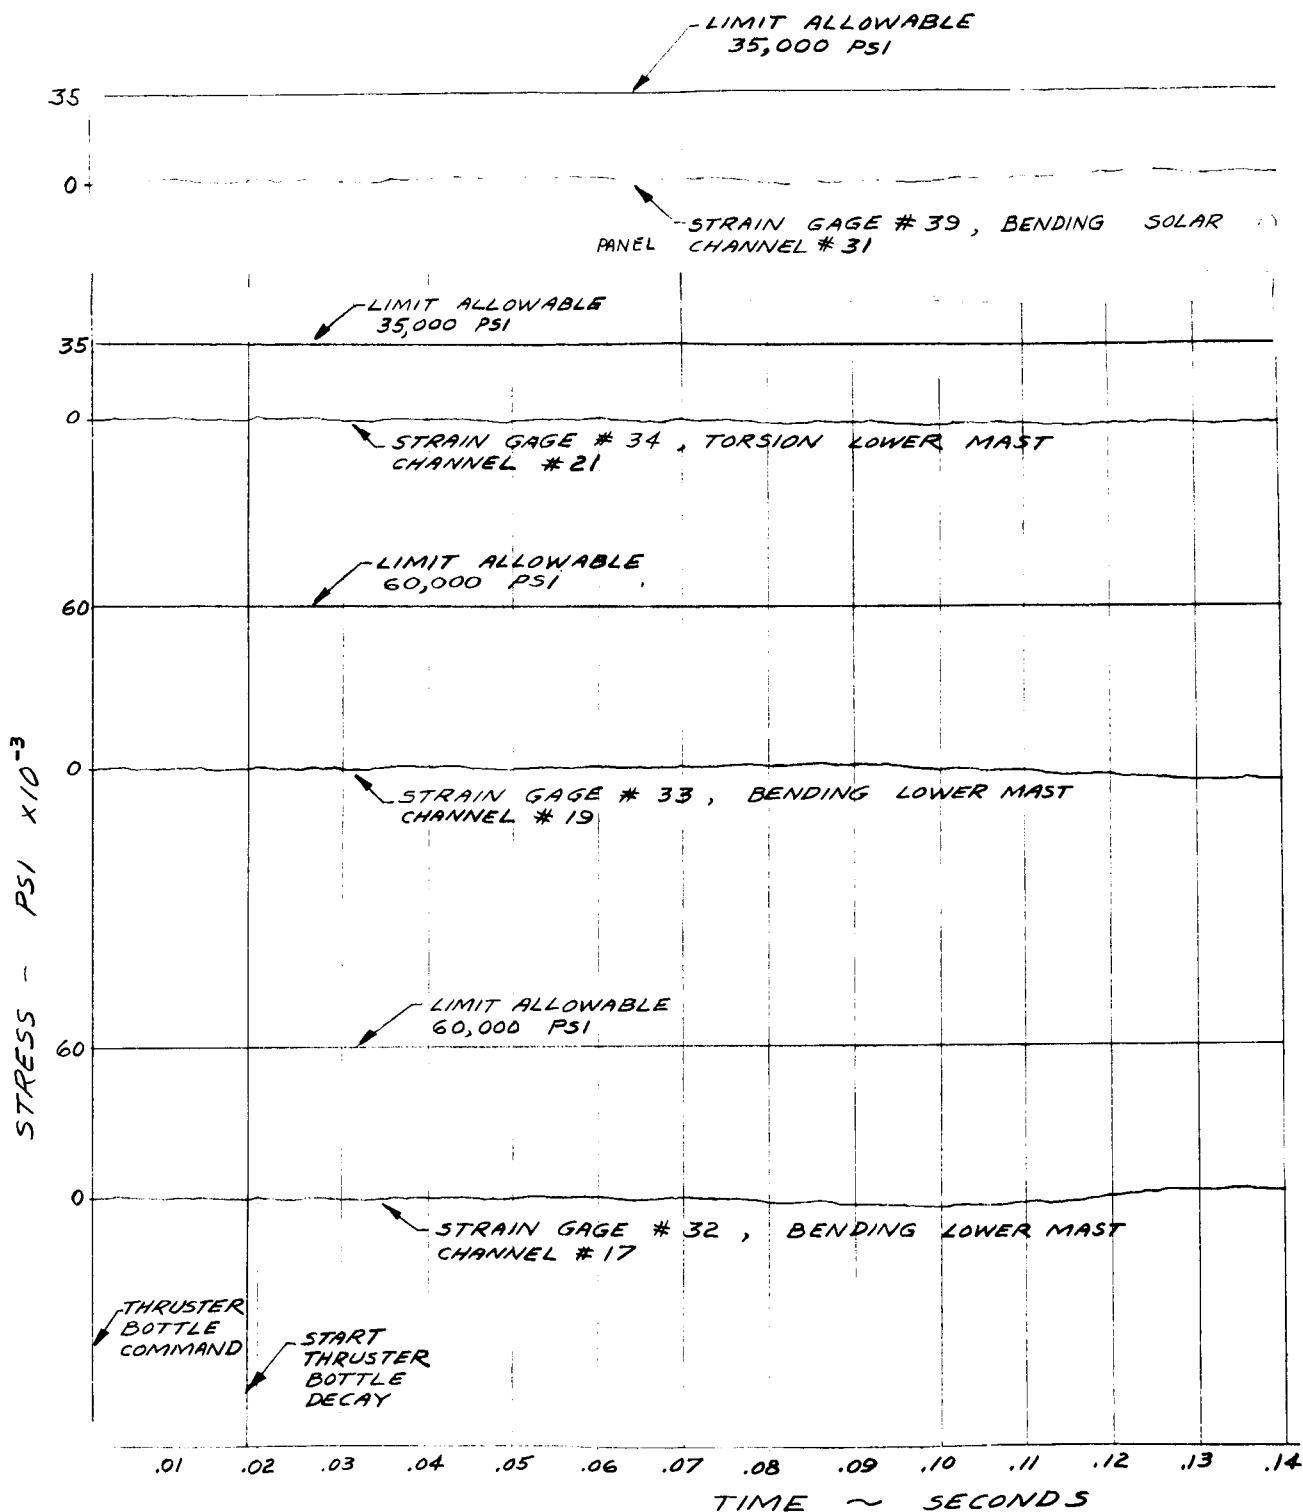
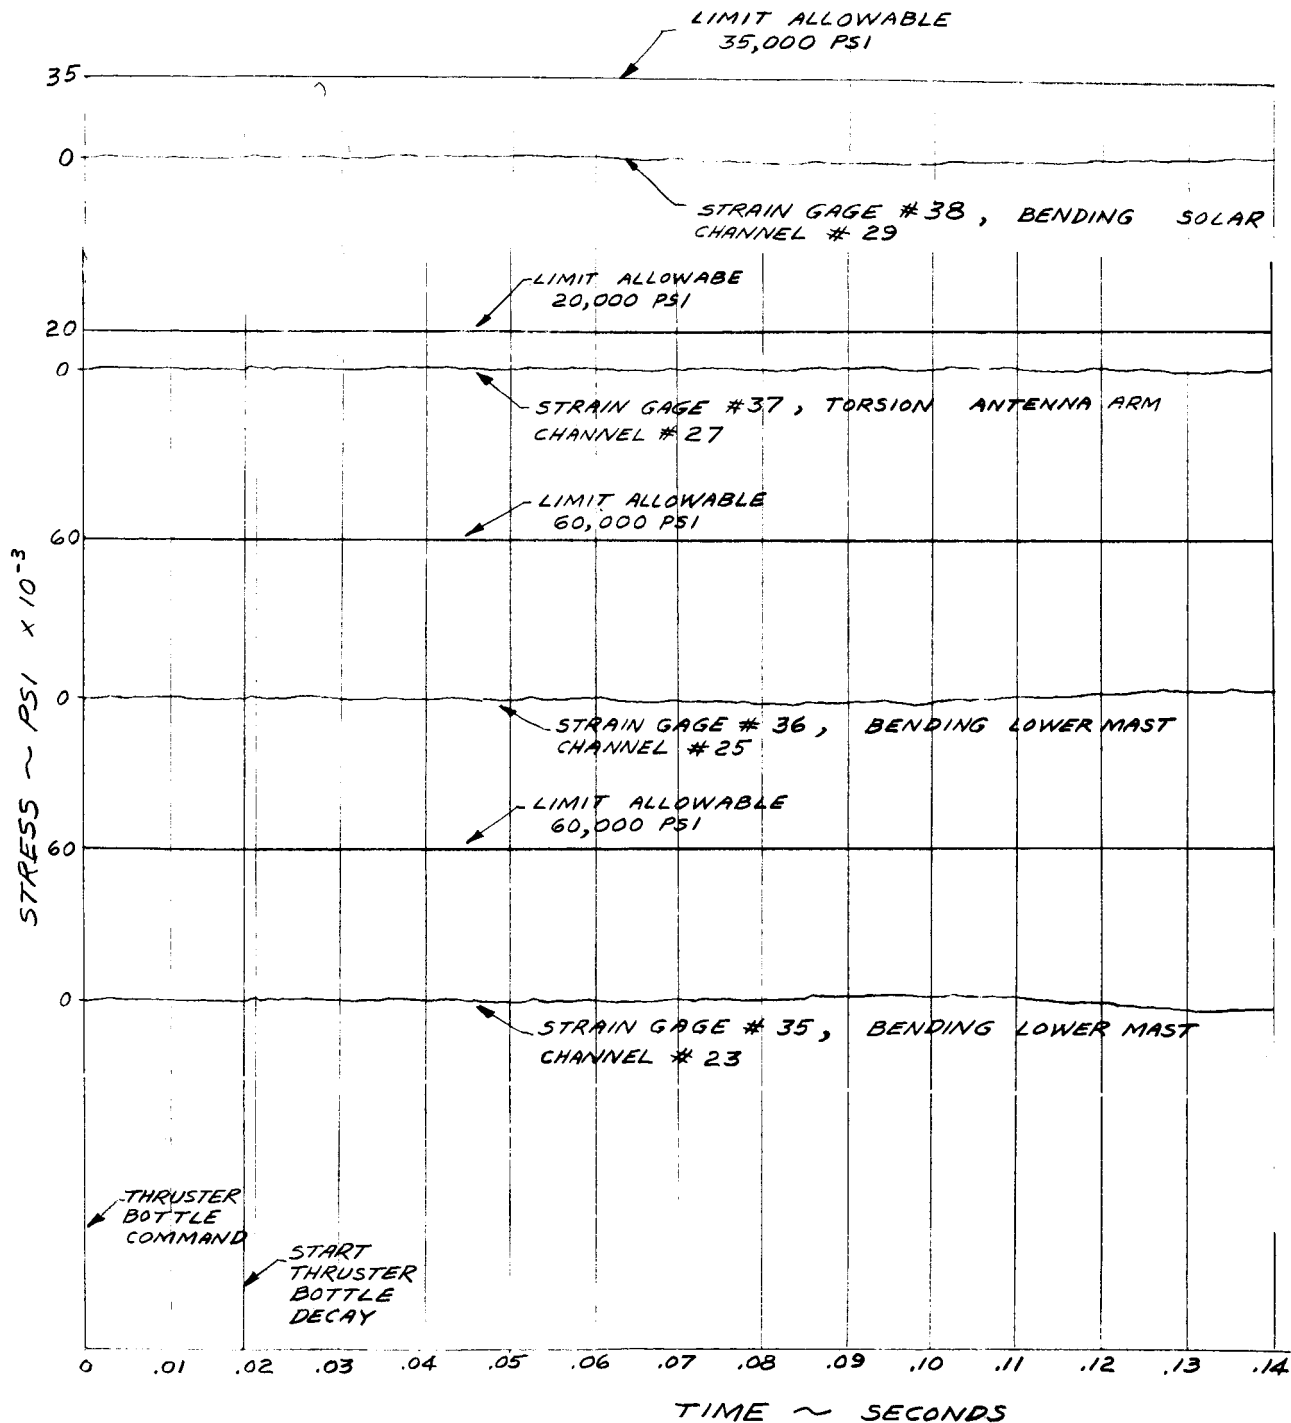
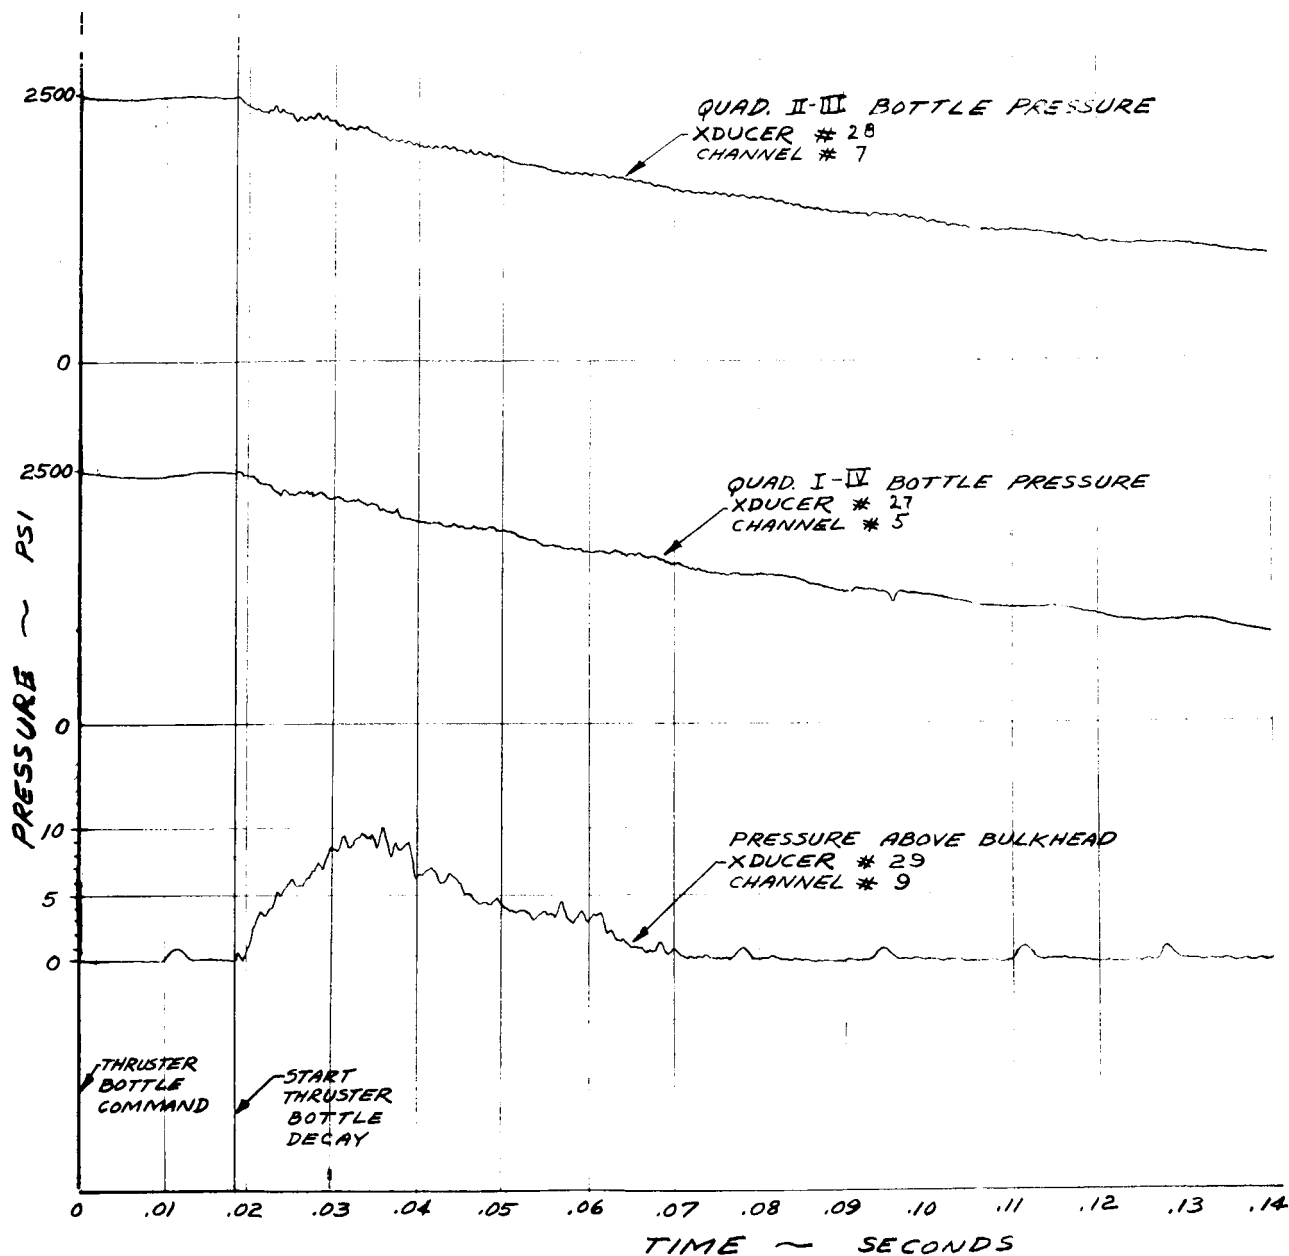
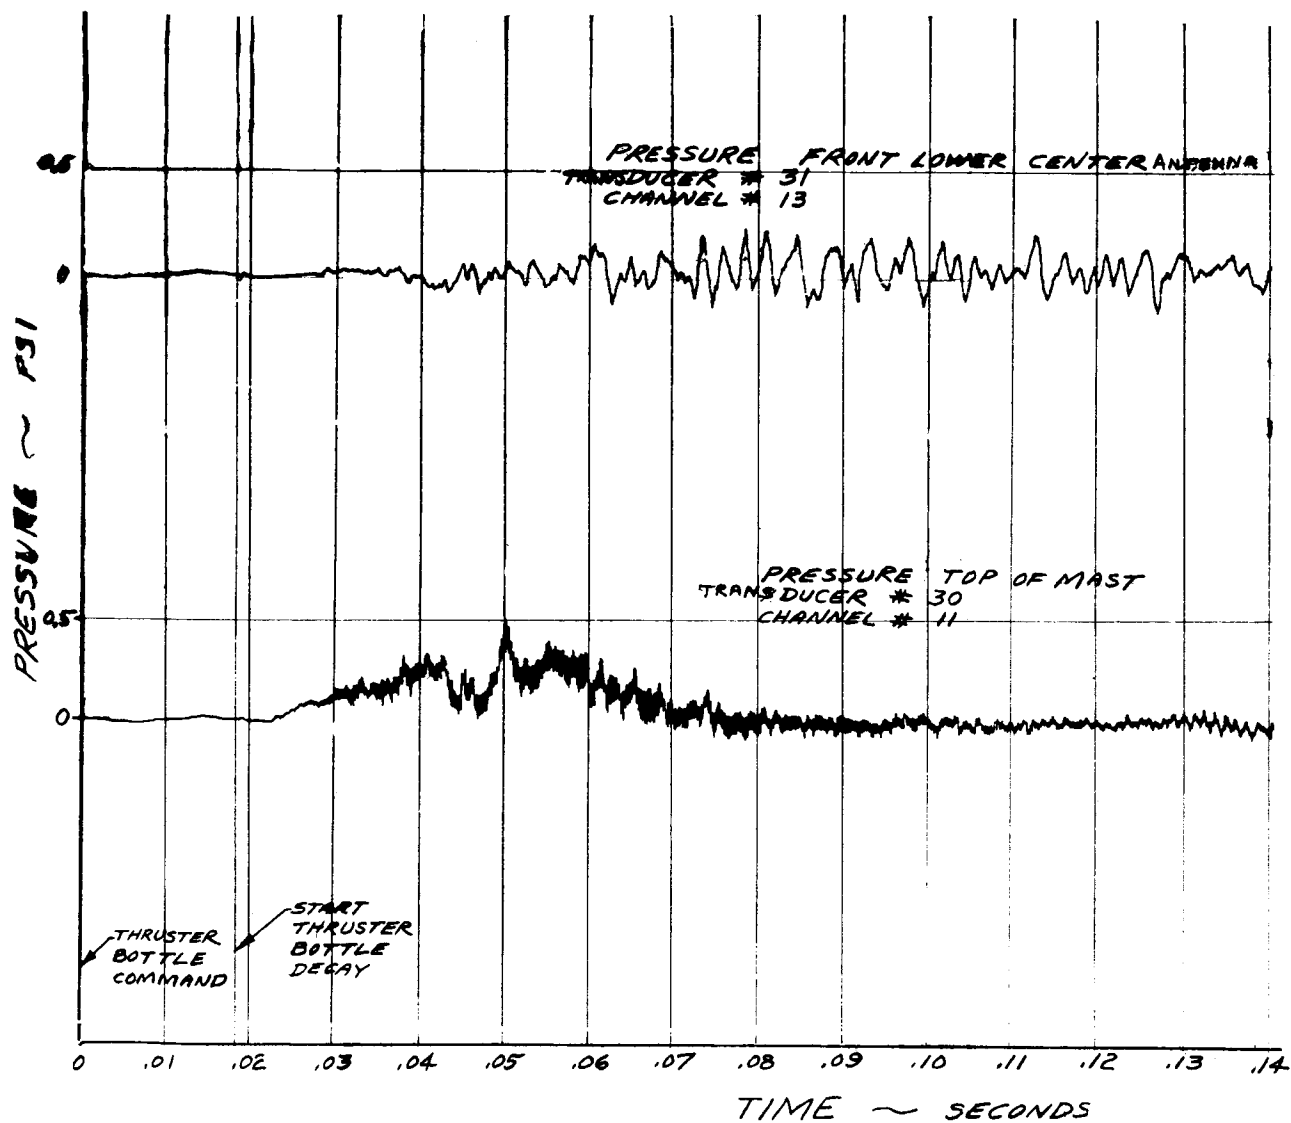
Strains on the mast during fairing jettison were measured by strain gages in location shown in figure 6(c). Gages number 38 and 39 measuring bending on the solar panel arms showed a maximum stress on 3500 psi (10 percent of maximum allowable stress). Gages 32, 33, 35 and 36 measuring bending on the lower mast showed a maximum stress of 8500 psi (14 percent of maximum allowable stress). Gage number 34 measuring torsion on the lower mast indicated a maximum stress of 3500 psi (10 percent maximum allowable stress) and gage number 37 measuring torsion on the antenna support arm showed a maximum stress of 4000 psi (20 percent of maximum allowable stress). Figure 20 shows the strain gage values.

Figure 20. - Nose fairing separation data. Test 4.

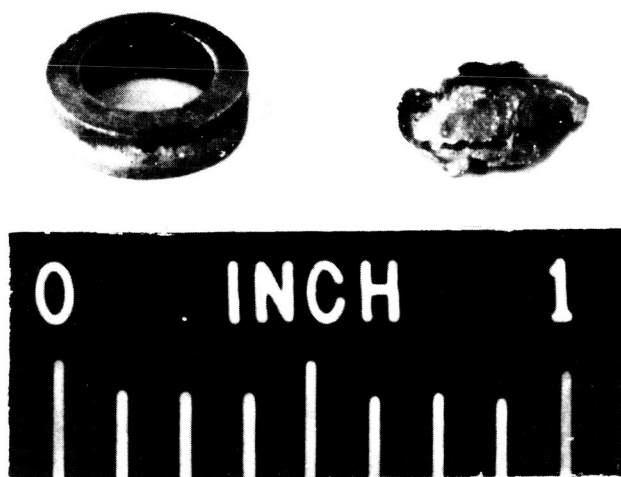
C-65-1385

The firing of the explosive bolts was accomplished before the test chamber was evacuated by manually closing the firing circuit. In preparing for this part of the test all explosive bolts were installed and torqued to required setting, squibs were installed, retainers installed on bolt housings, and fairings installed. During installation of the squibs, one squib or matching bolt was found to have defective threads so that the squib and bolt became galled. The threads between the two parts of the bolt were also found to be galled and the bolt was removed by over torquing and breaking it into two parts. After the defective bolt was replaced the actual firing of the bolts was accomplished. All bolts separated but various fragments were found upon removing the fairings. Shrapnel from the bolts up to pieces with maximum dimension of 1/16 inch were found. The charge retainer and diaphragm of the squibs were also found inside the bolt fairings and inside the nose fairing. Figure 27 shows some of the parts recovered.

Figure 27. - Shrapnel from explosive bolt squibs.

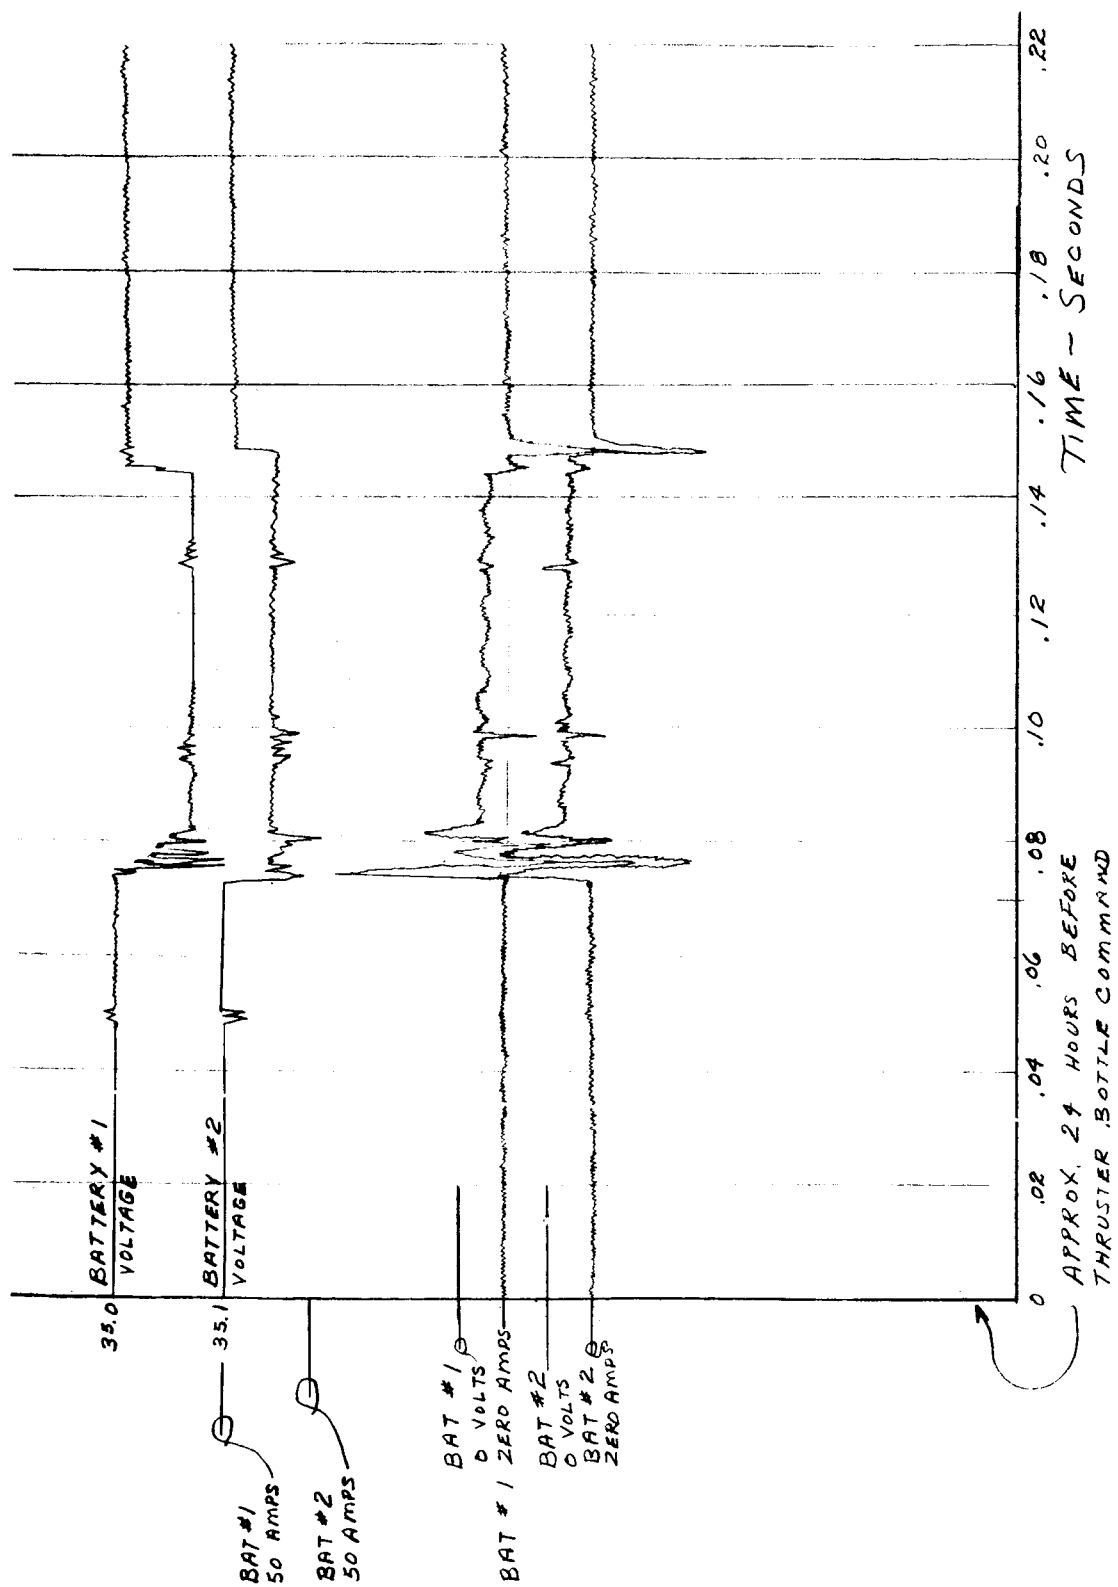
(f) Battery 1 and 2 voltages and current.

The voltage and total current from the two AC4 flight type batteries are shown for tests 7 and 8 in figures 28 and 33. These batteries have a 35 volt no load level and will supply 0.5 amp hours of current. The voltage from each battery dropped from 5 to 7 volts for approximately 0.1 second and then returned to its starting voltage (35 volts). Current drain varied from 10 to 19 amps per battery. In no case did the batteries go below the minimum voltage level of 25 volts specified for a 20 amp load. Checkout of the pyrotechnic electrical circuits should be carefully done with devices having enough internal resistance so that the thermal overload relay in the circuit is not actuated.

Figure 28. - Continued.

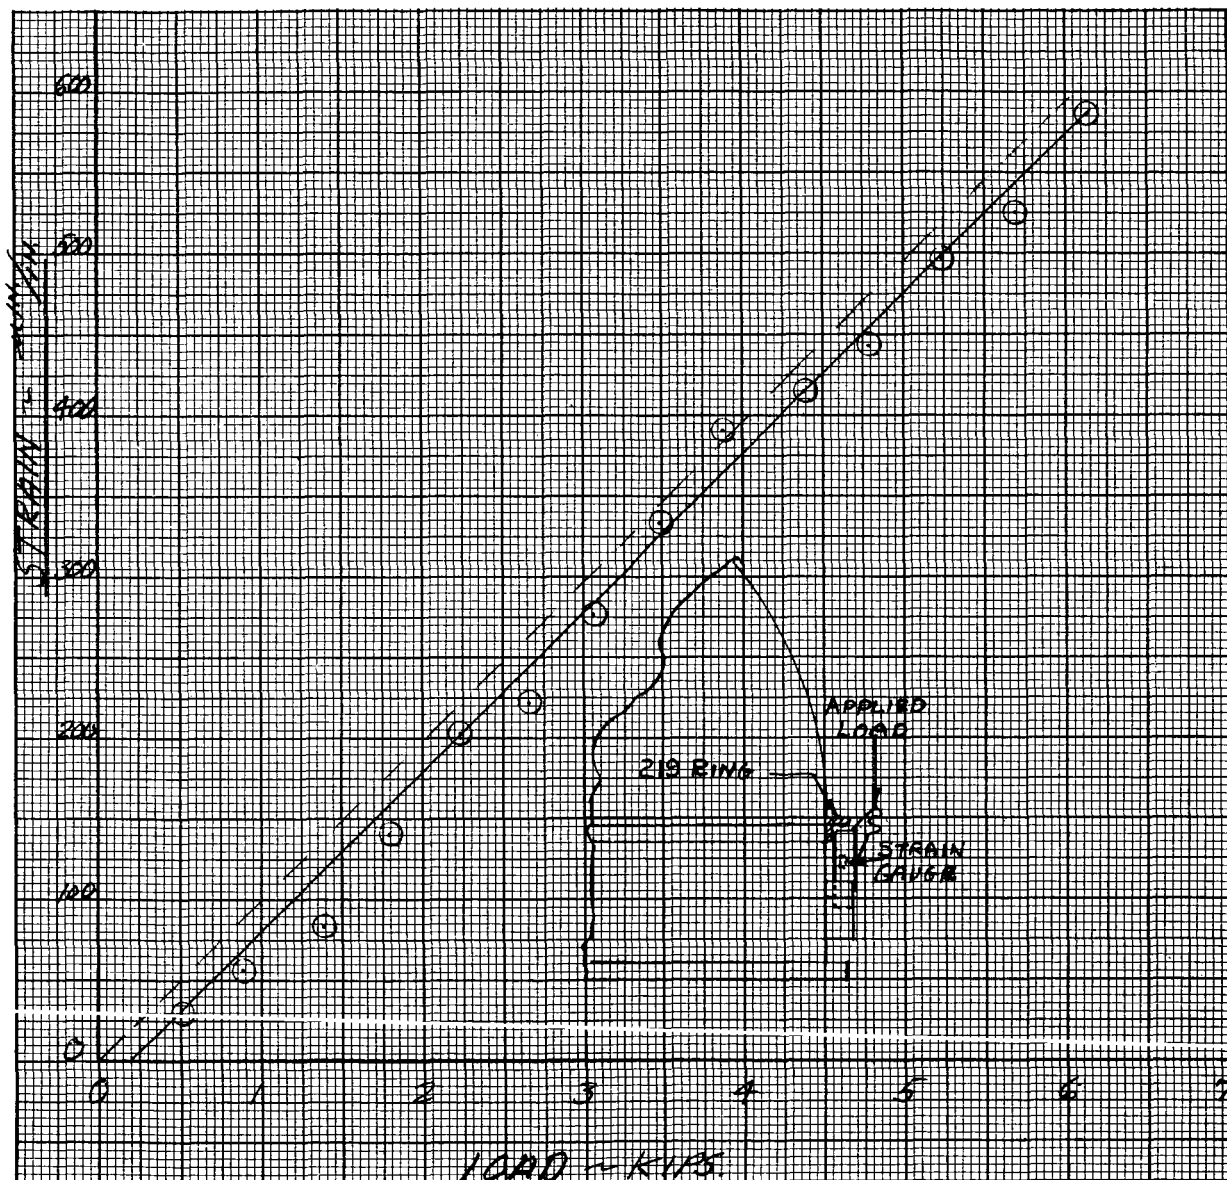
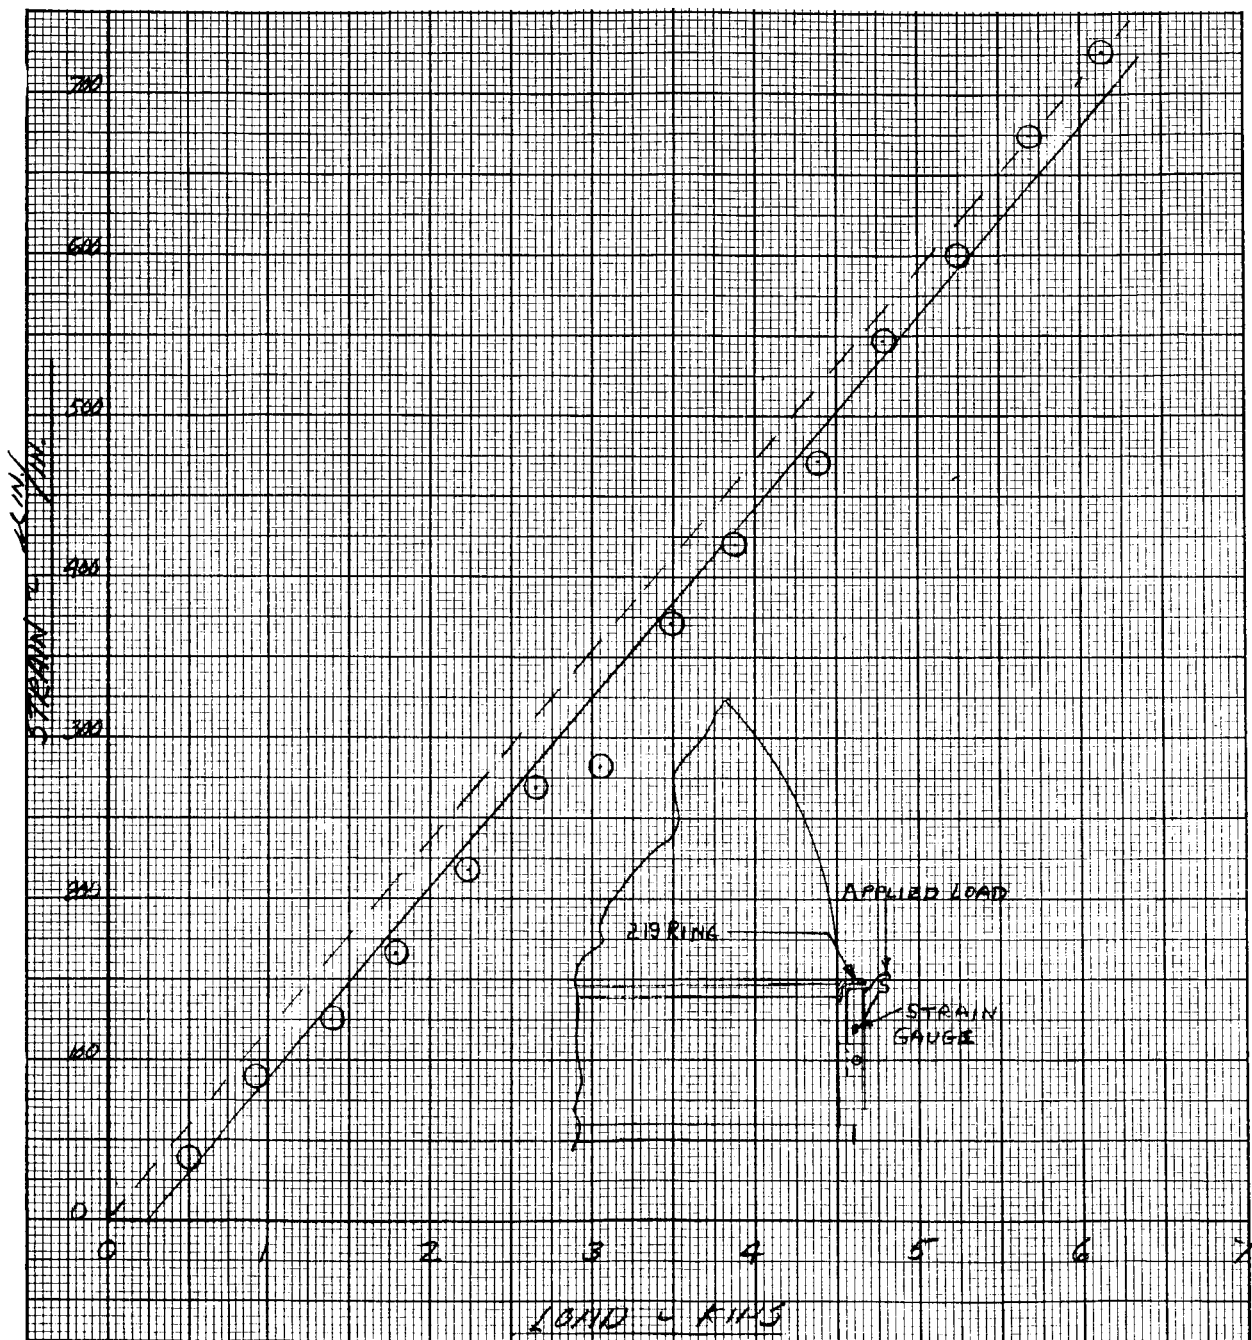
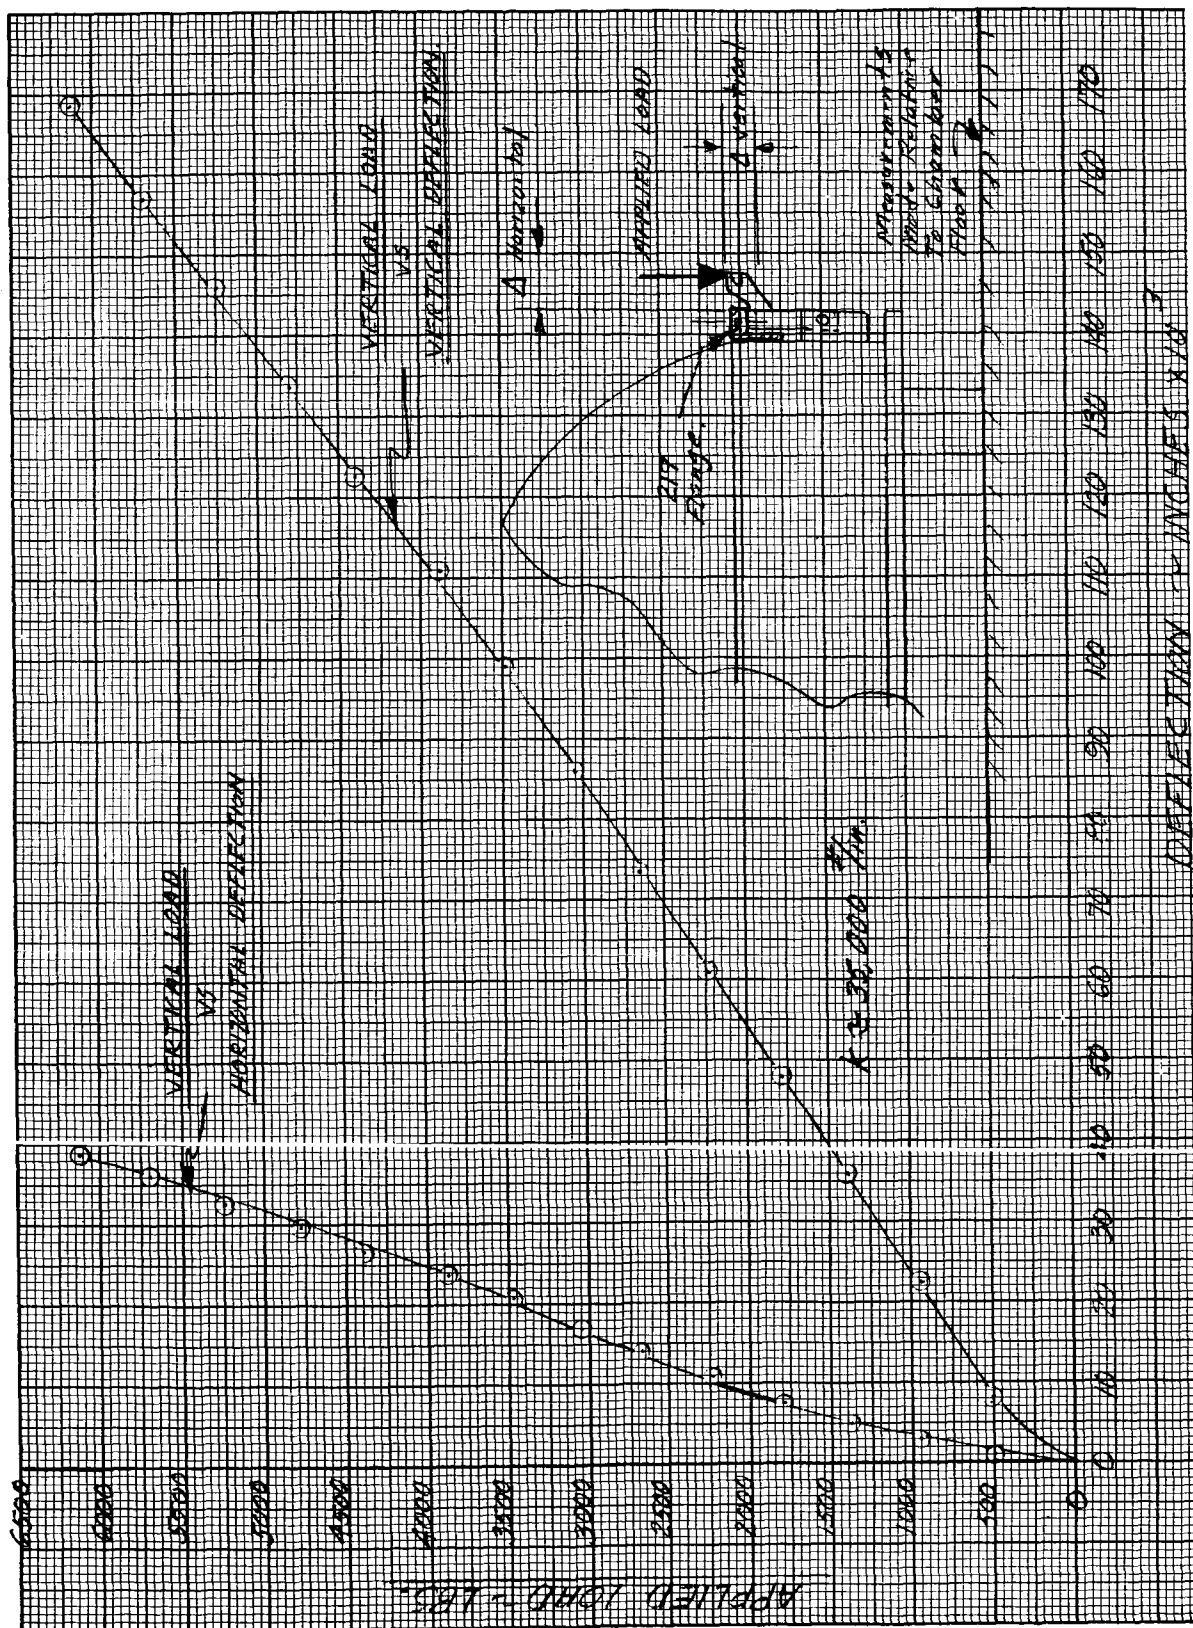
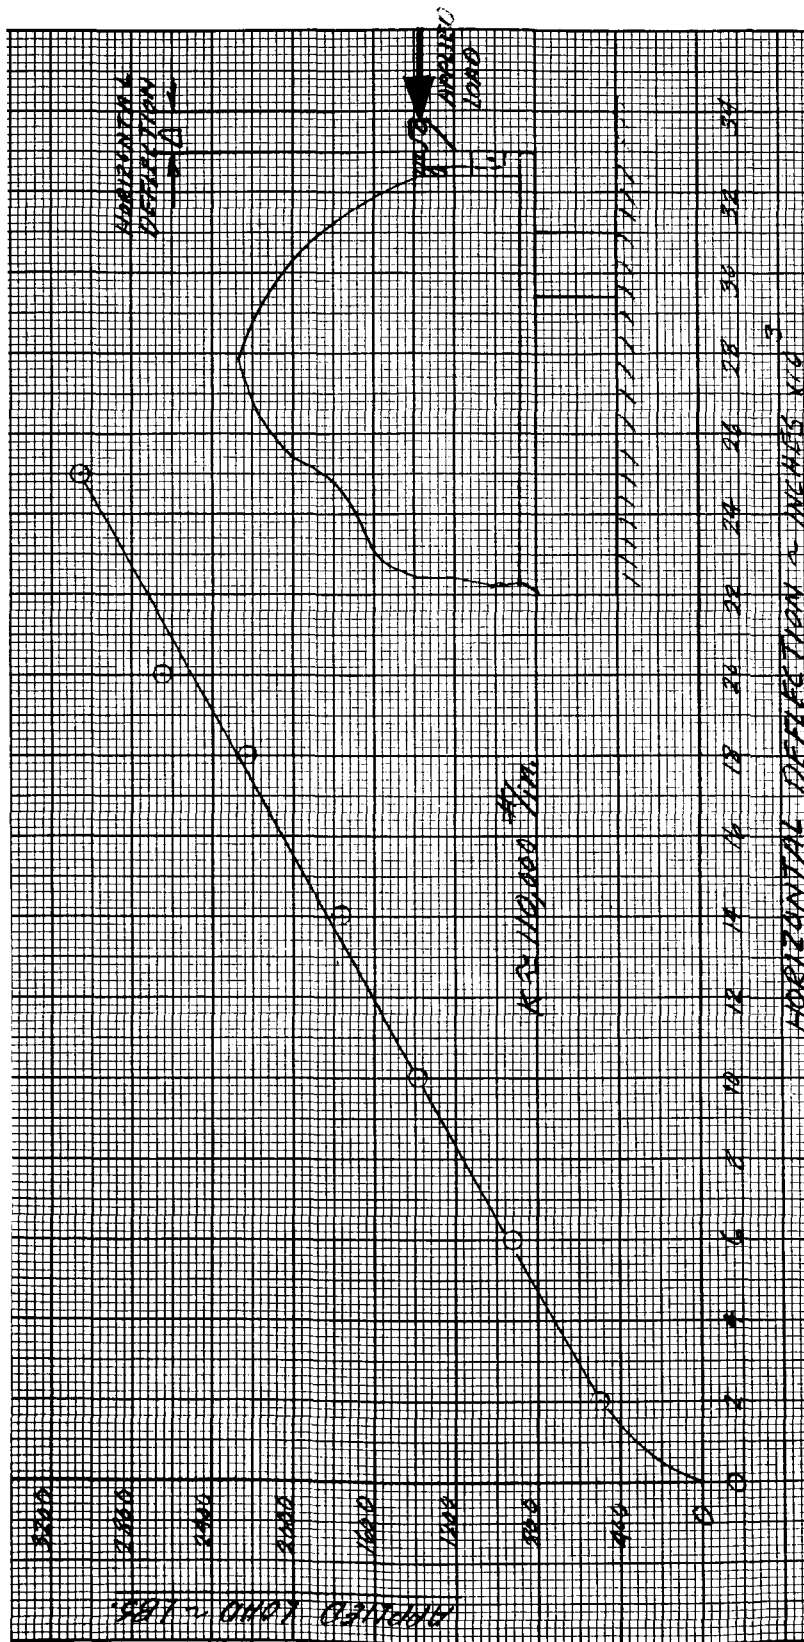
the simulated forward bulkhead used in the LeRC tests was higher than that for an actual flight tank. The spring constants of the forward bulkhead used in these tests and the strain gauge calibration of the gauges on the hinge are shown in figure 30. The spring constants of the hinge attached to the actual flight tank are as follows: vertical is 36,700 pounds per inch and horizontal is 9000 pounds per inch.

Figure 30. - Calibration of tank half finger strain gages and spring rate determination.
